OPERATION AND MAINTENANCE MANUAL

LONGVIEW LAKE

APPENDIX IV

CONSTRUCTION FOUNDATION REPORT

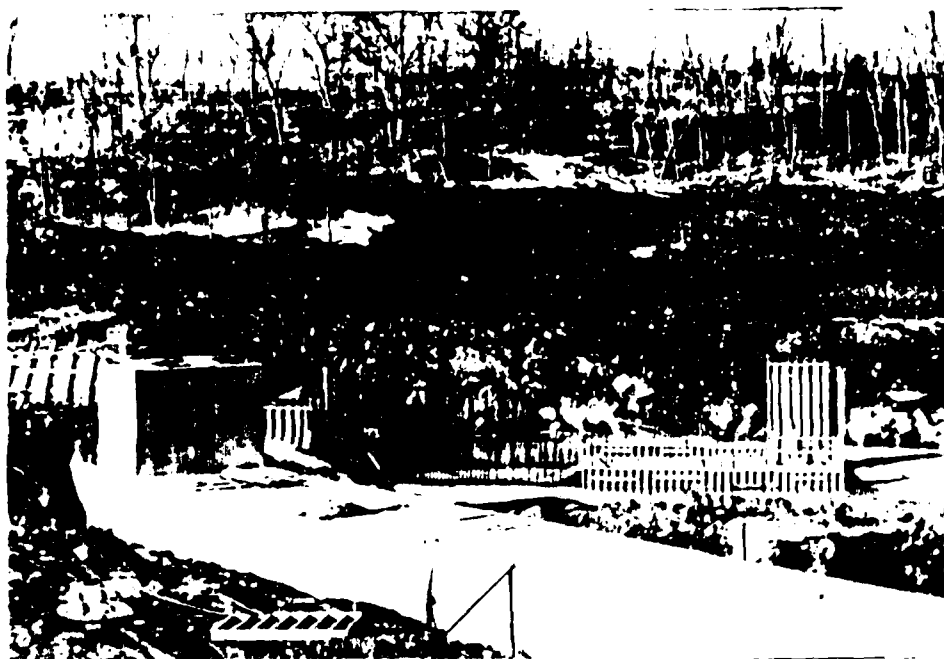
d. Longview Lake, 1 Dec 80, Neg. No. 262.
Look west at slides on left side of outlet works
excavation. This is same area of slides which
occurred on 23 Mar 80. See Photo 2.

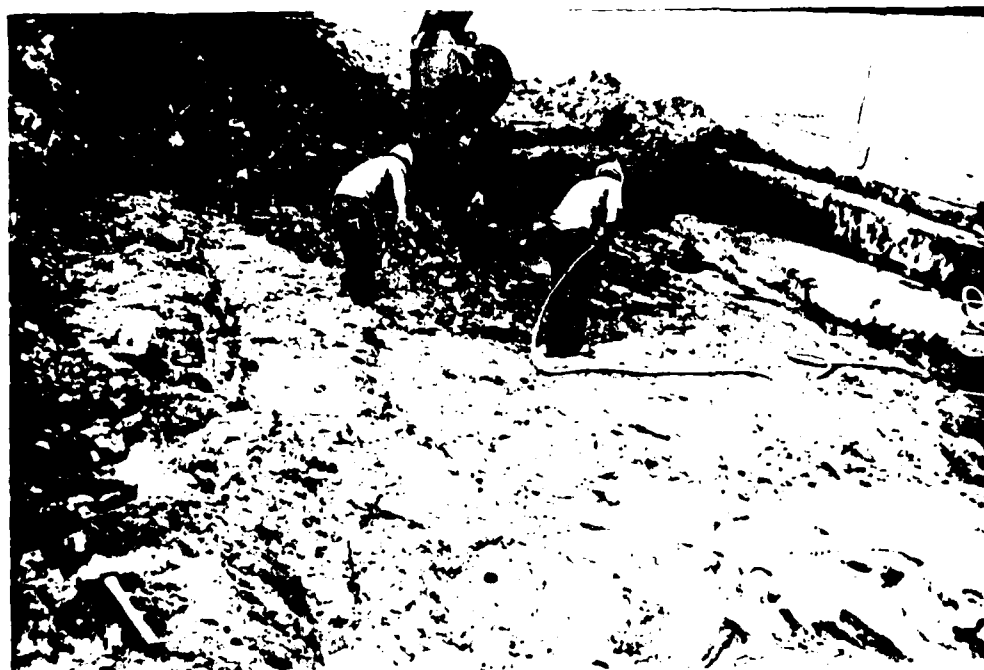
19. Longview Lake, 17 Feb 81, Neg. No. 531.
Camera at O.W. Station 55+50±, range 90' right.
Look west at repaired slide area. See also photo 26.

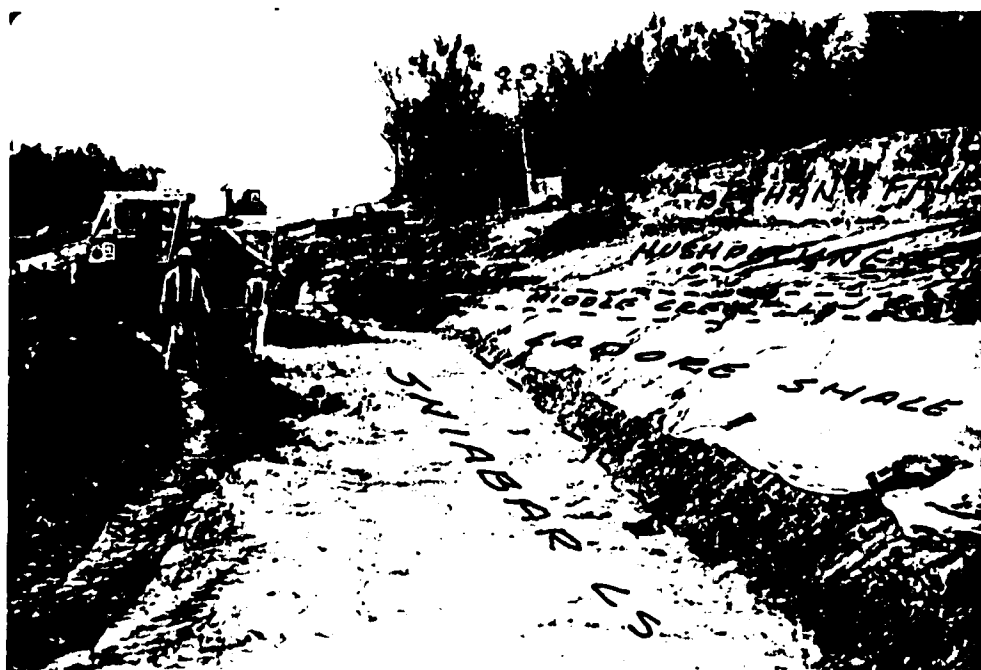
135. Longview Lake, 2 Oct 81, Neg. No. 1132.
Station 100+75. Look downstream slickensides in
Ladore shale.
